Methodological Approach to Conservation: Physical Approach

LESSON 13. SURVEY, MAPS AND TESTS ON WOODEN CONSTRUCTION

SURVEY, DAMAGE MAPS AND TESTS ON WOODEN CONSTRUCTION

**DIAGNOSTICA STRUTTURALE SULLA COPERTURA LIGNEA
DELLA BASILICA DI S.APOLLINARE IN CLASSE RAVENNA**

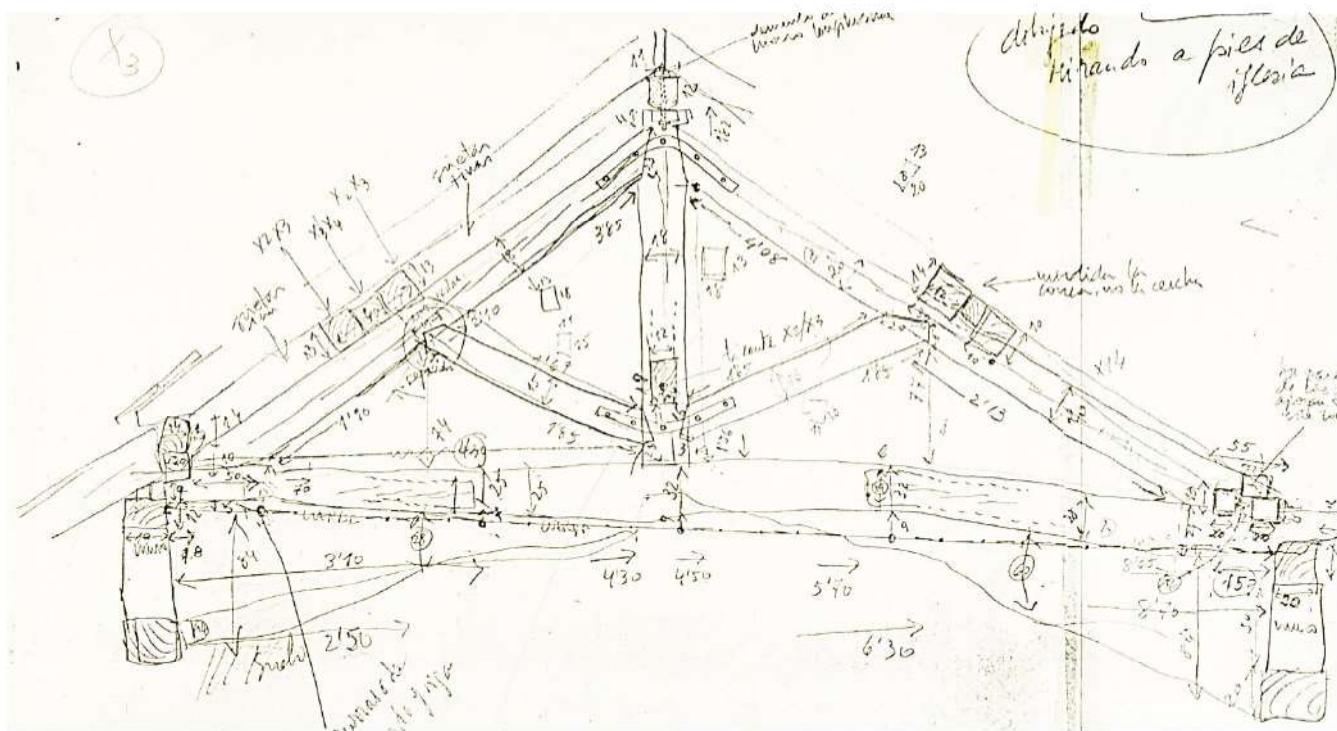
Sketch of a wooden truss with measurements and constructive indications.

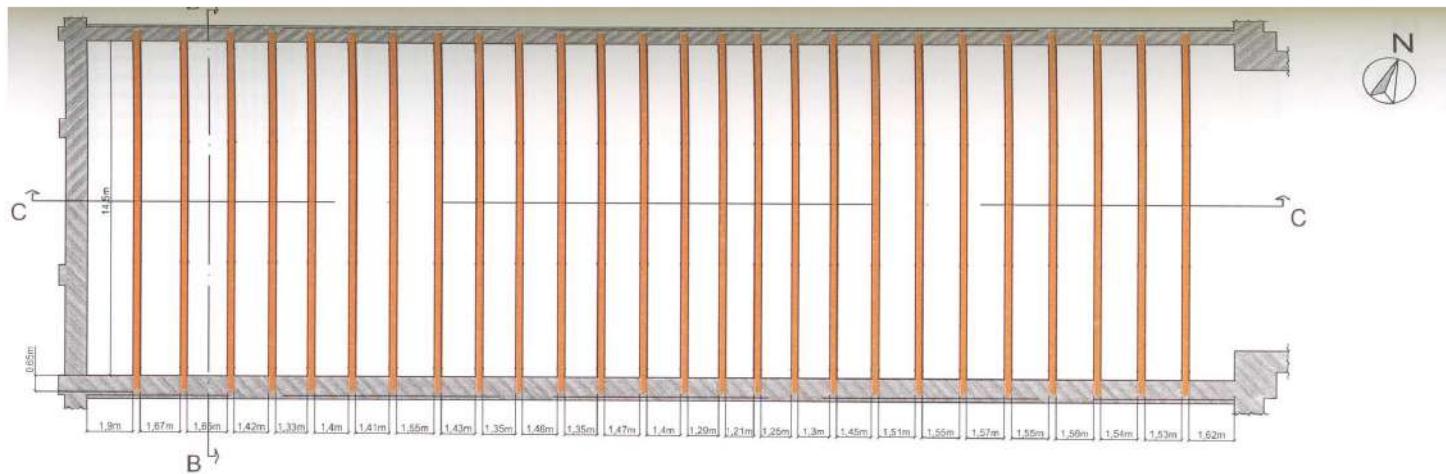
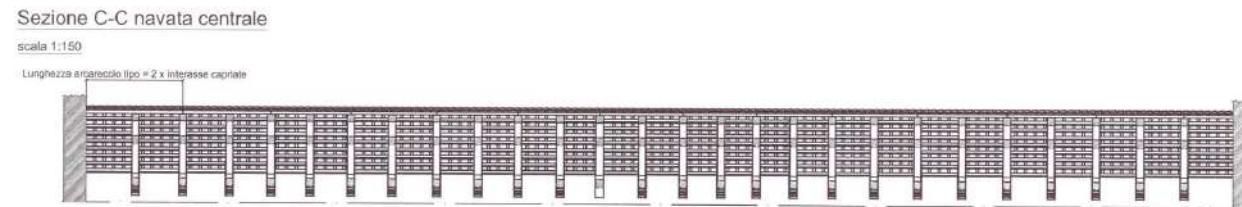
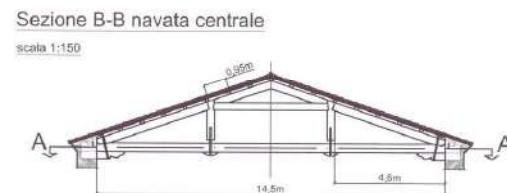
n° Comm. 3151/05
ALLEGATO:
rilievo della copertura - sezioni navata centrale

Roof survey with central nave sections.

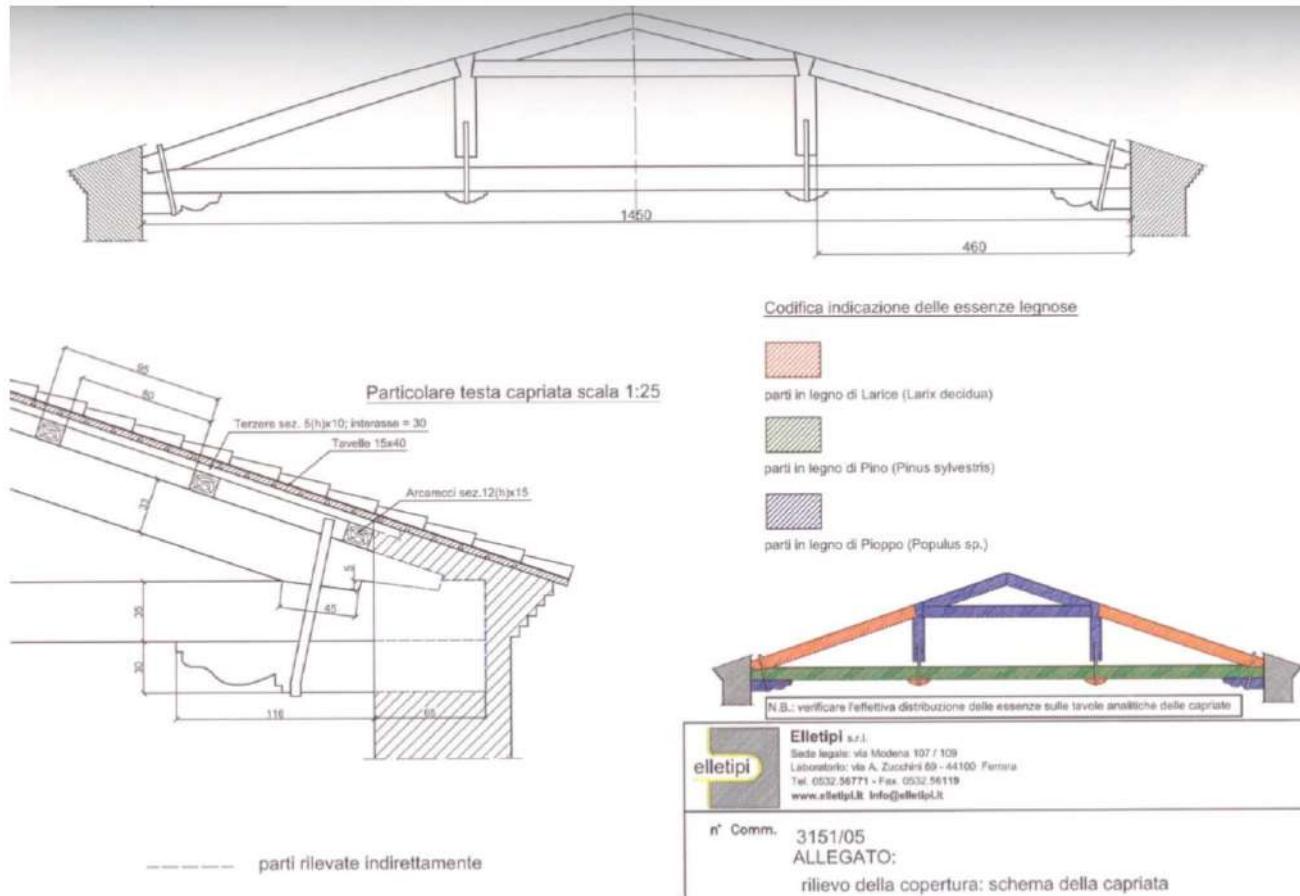
It is represented the constructive solutions of the support points of the truss. The following drawing details the type of wood used in each element.

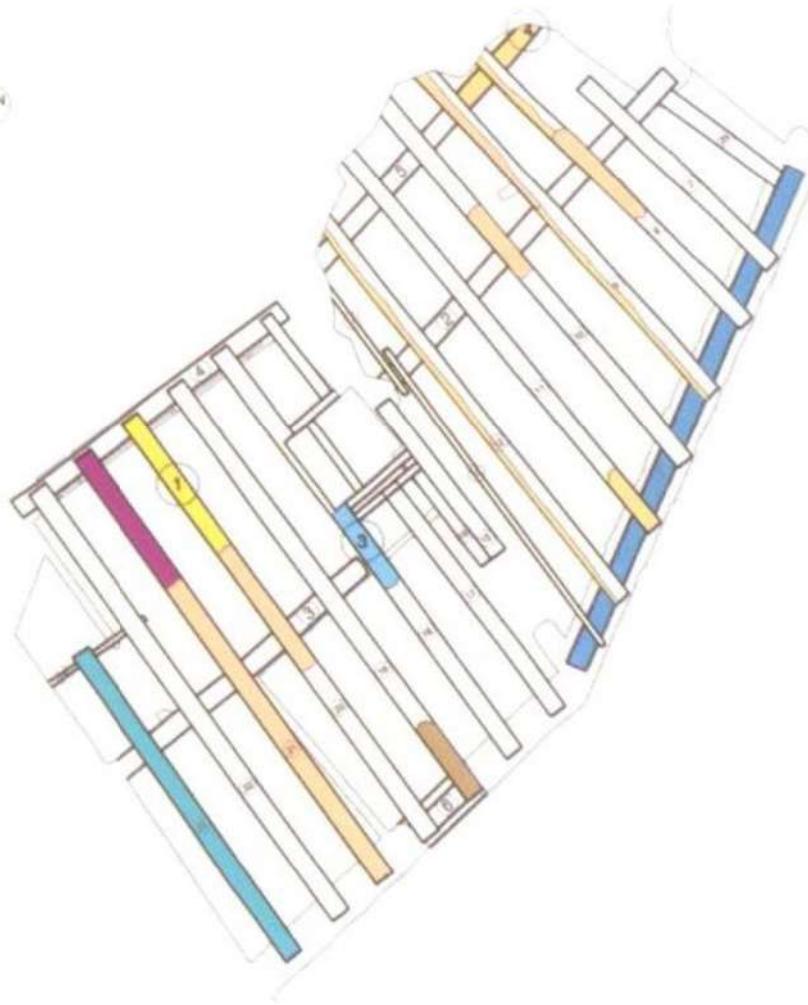
Damages types identification

- Xylophagous insects
 - Xylophagous insects
 - Xylophagous insects
 - Cork-like wood and moisture stains
 - Cork-like wood
-
- Quartered wood
 - Rotting
 - Moisture stains
 - Xylophagous insects and rotting
 - Cork-like and rotting
-
- Quartered wood and rotting
 - Quartered wood and xylophages
 - Fungus
 - Birds' nests
 - Breakage

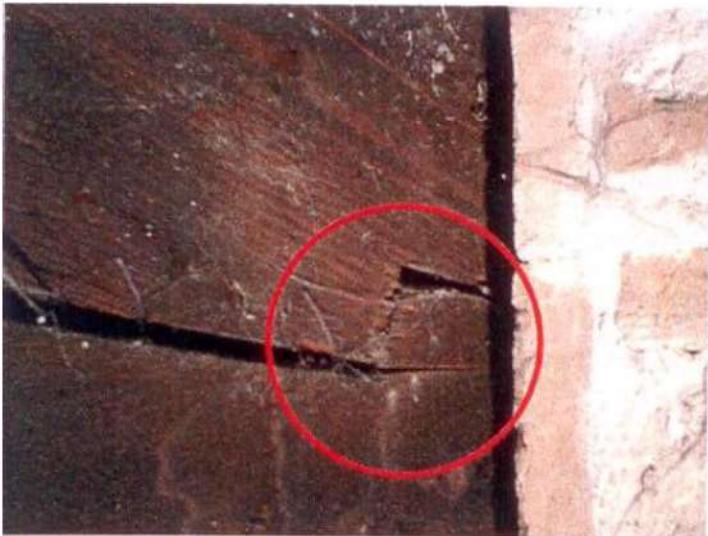
Suffering of the cutting tooth (left)

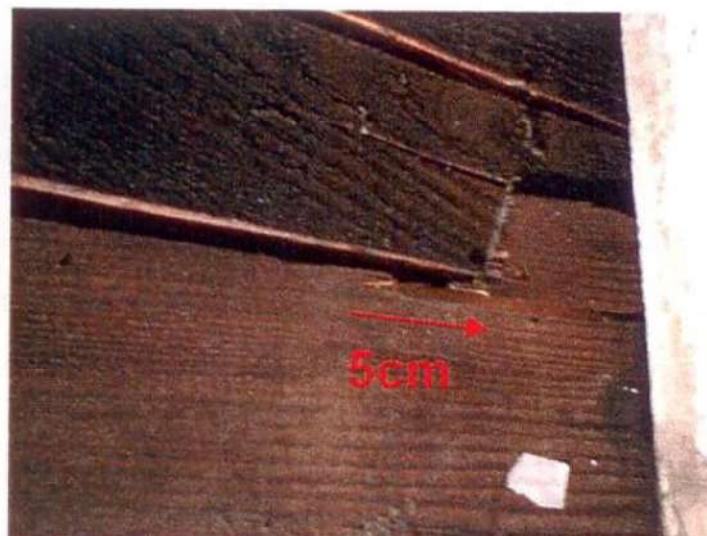
Breakage with relative sliding of the elements (right).

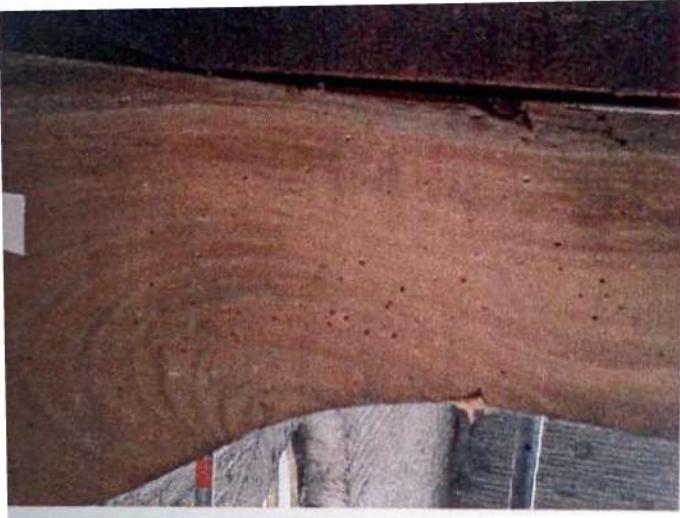
Attack of anabids xylophagous (left)

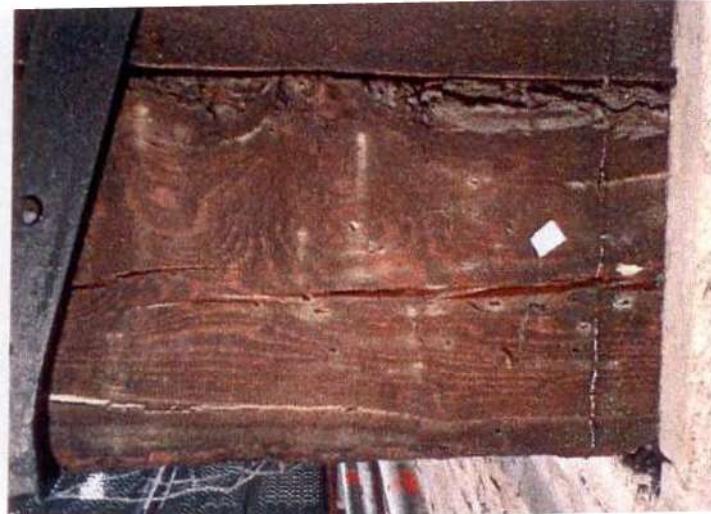
Attack of cerambicides xylophagous (right).

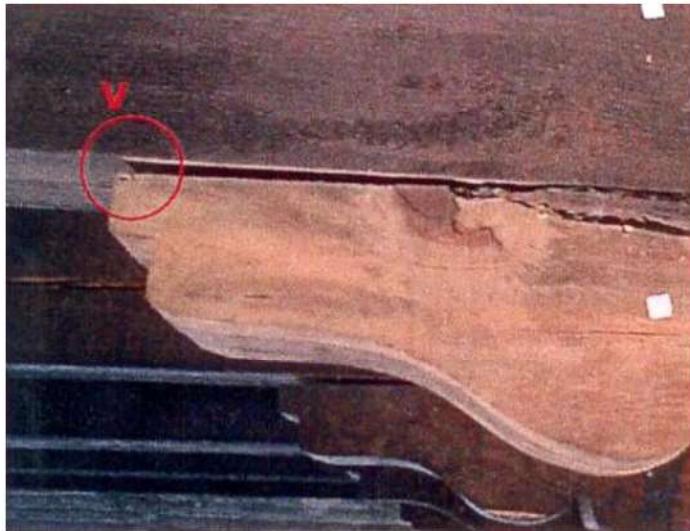
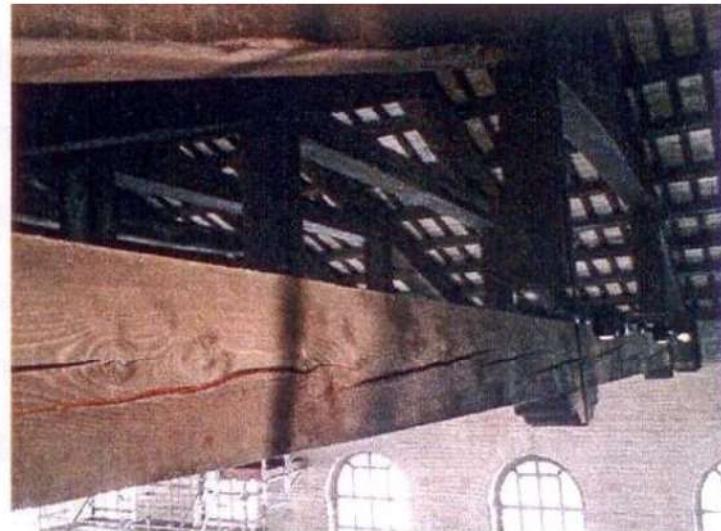
Vertical deviation between bracket and tie-beam (left) and longitudinal fissures due to tie-beam shrinkage (right).

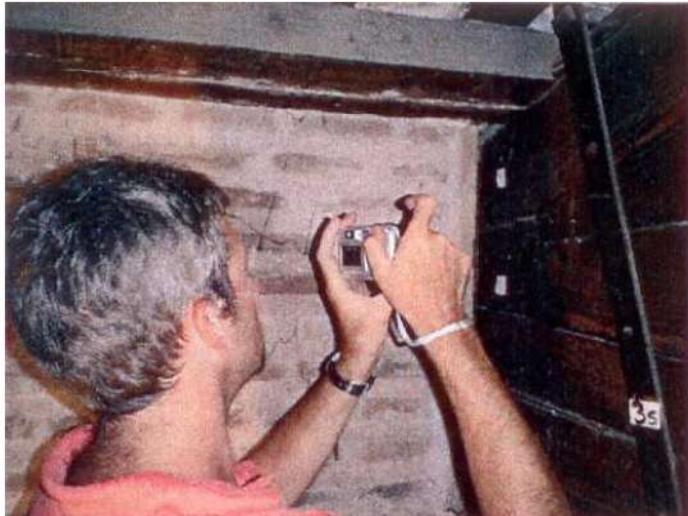
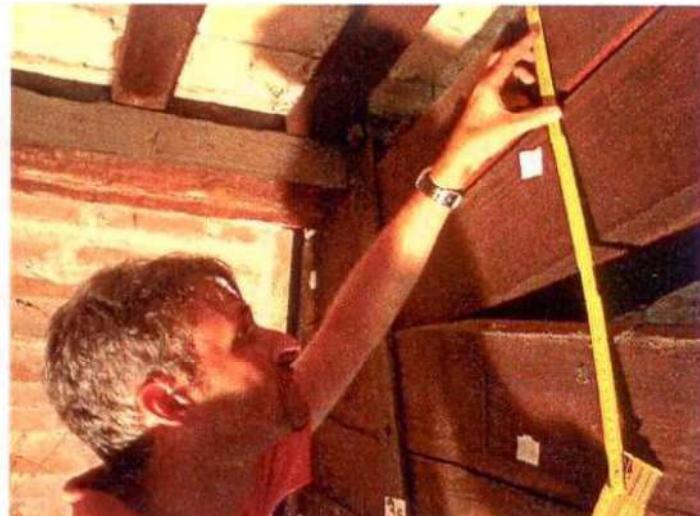
Visual, photographic and geometrical survey.

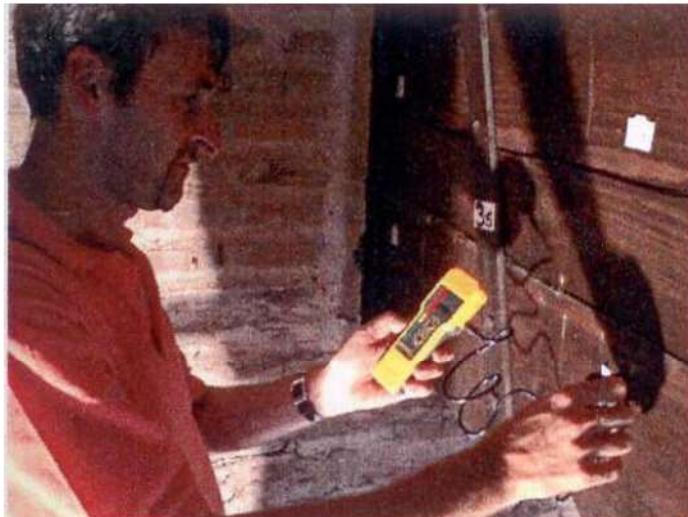
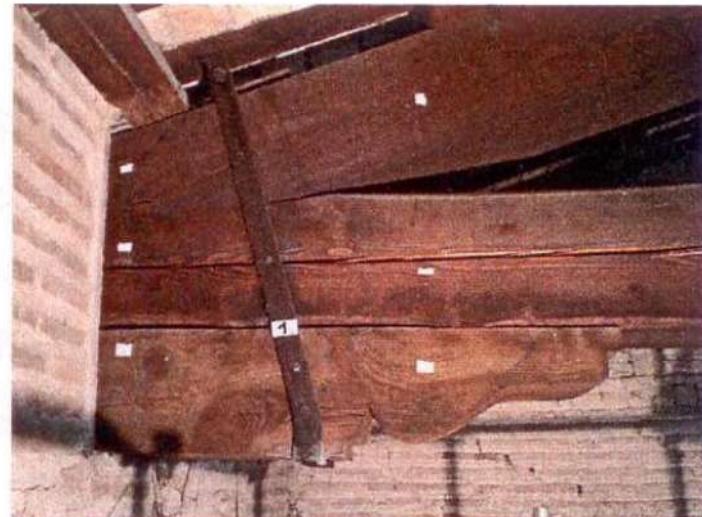
Moisture survey (left) and example of the coding assigned to the truss head with indication of the execution points (right).

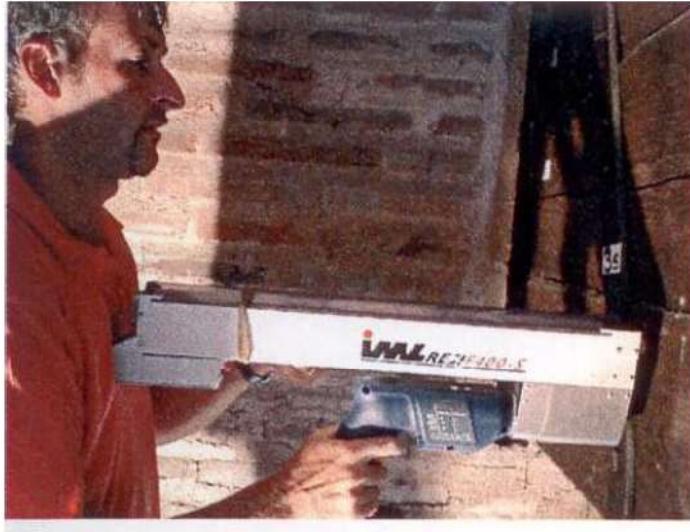
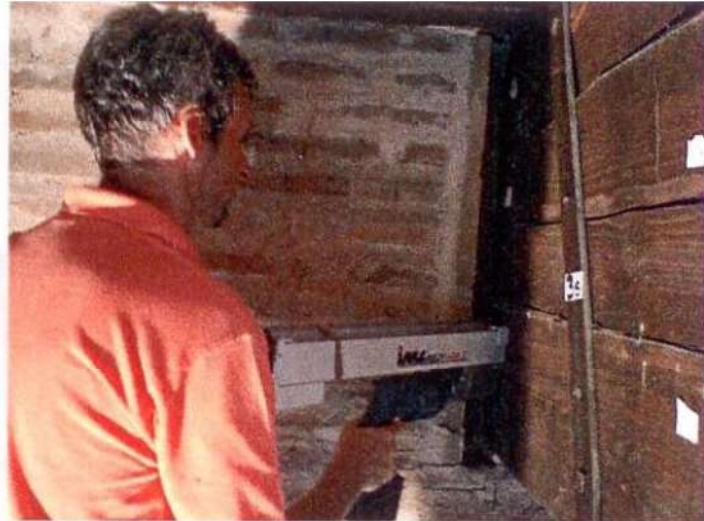
Perforations with resistograph in span (left) and in correspondence of the support (right).

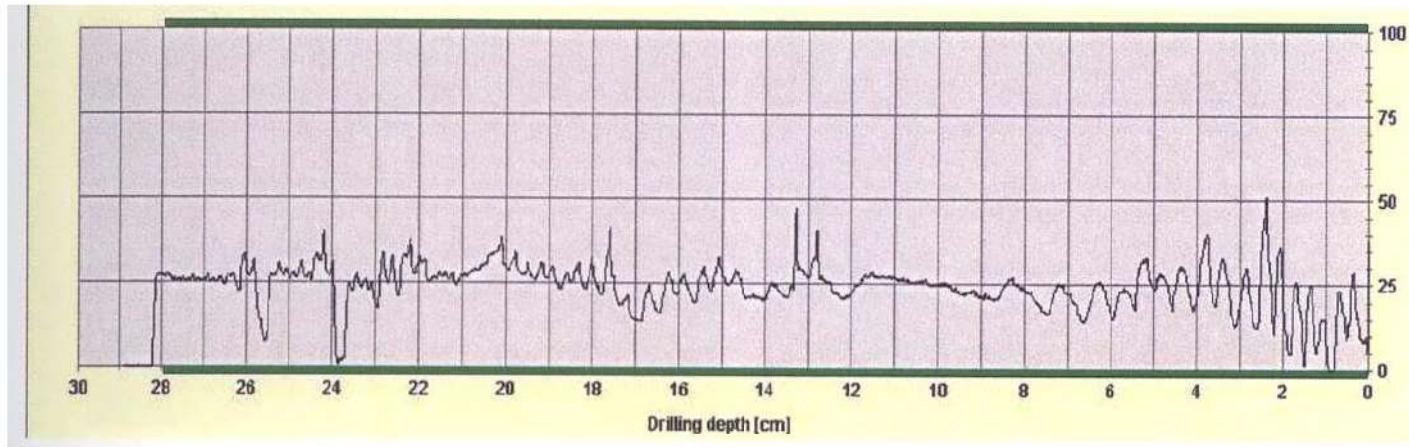
Drilling depth-Resistance diagram for a «healthy» shelf.

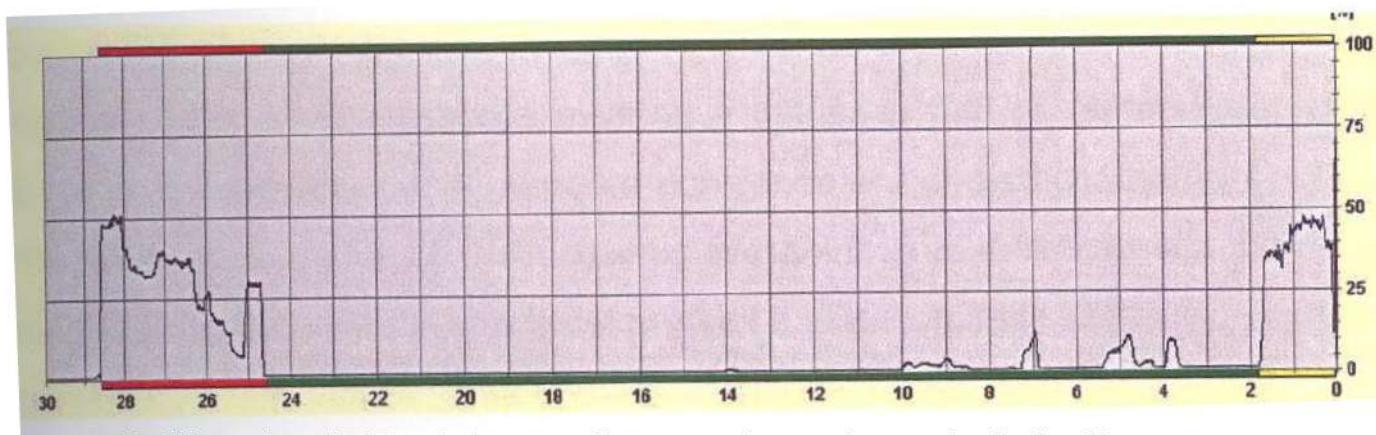
Drilling depth-Resistance diagram for a degraded shelf.

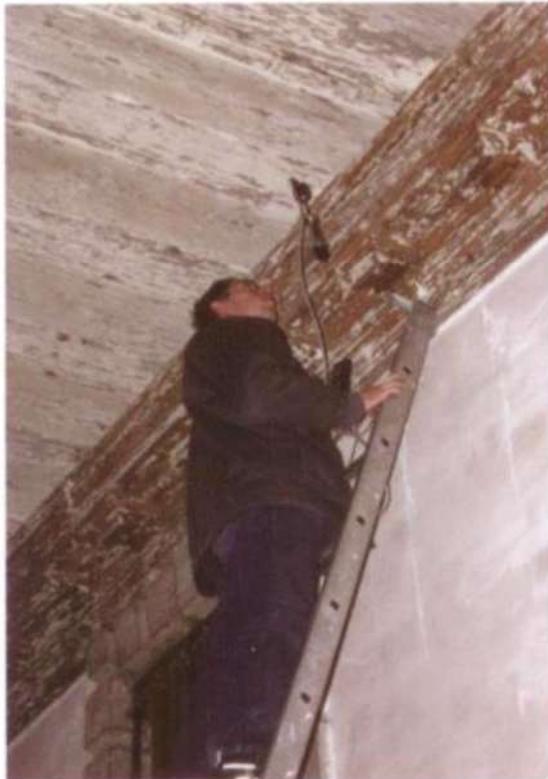
Reading the humidity inside the beam.

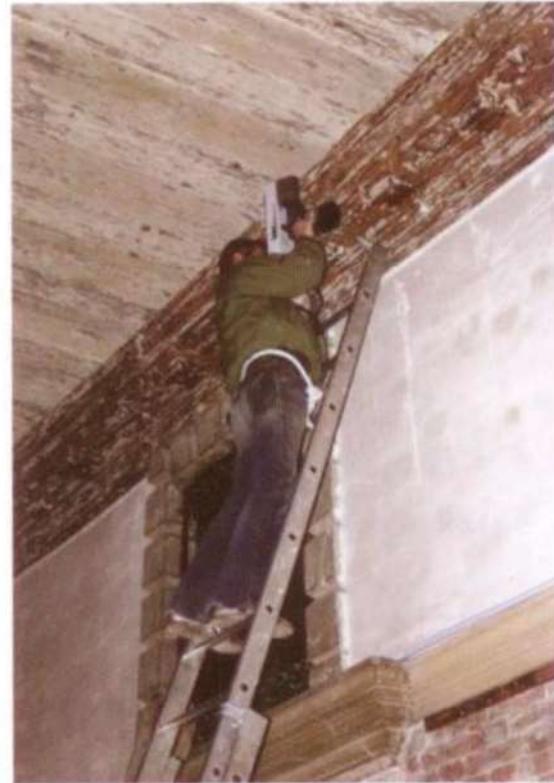
Performing the penetrometer test.

Penetrometer tests on wood
(PP.MM. Laboratory, Politecnico di Milano)

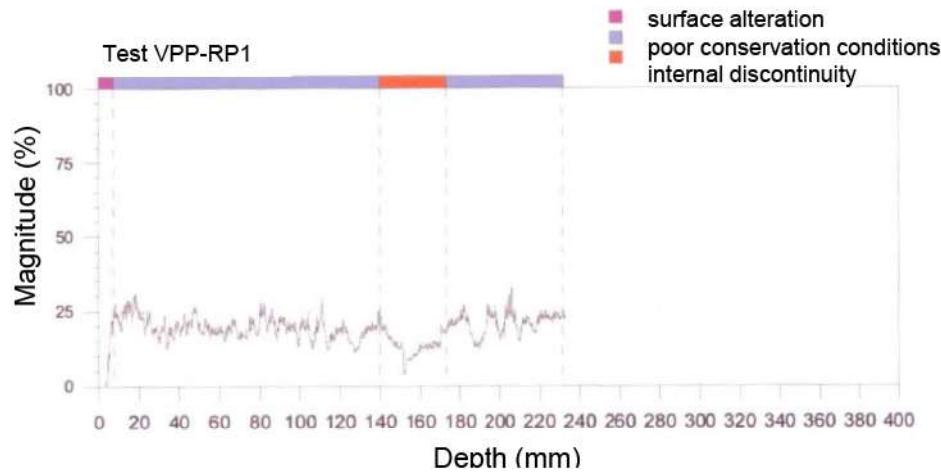
Densiometric profile obtained from the VPP-RP1 test
