Heritage Problems. Causes. Solutions

The aim of this course is to familiarize the student with a set of criteria and architectural intervention techniques, to expand their theoretical knowledge of the construction systems, analysing the causes that produce the different damages and the possible compatible consolidation solutions.

**Project "SURE - Sustainable Urban Rehabilitation in Europe"
implemented in frames of Erasmus+ Programme
Key Action 2: Strategic Partnership Projects
Agreement n° 2016-1-PL01-KA203-026232**

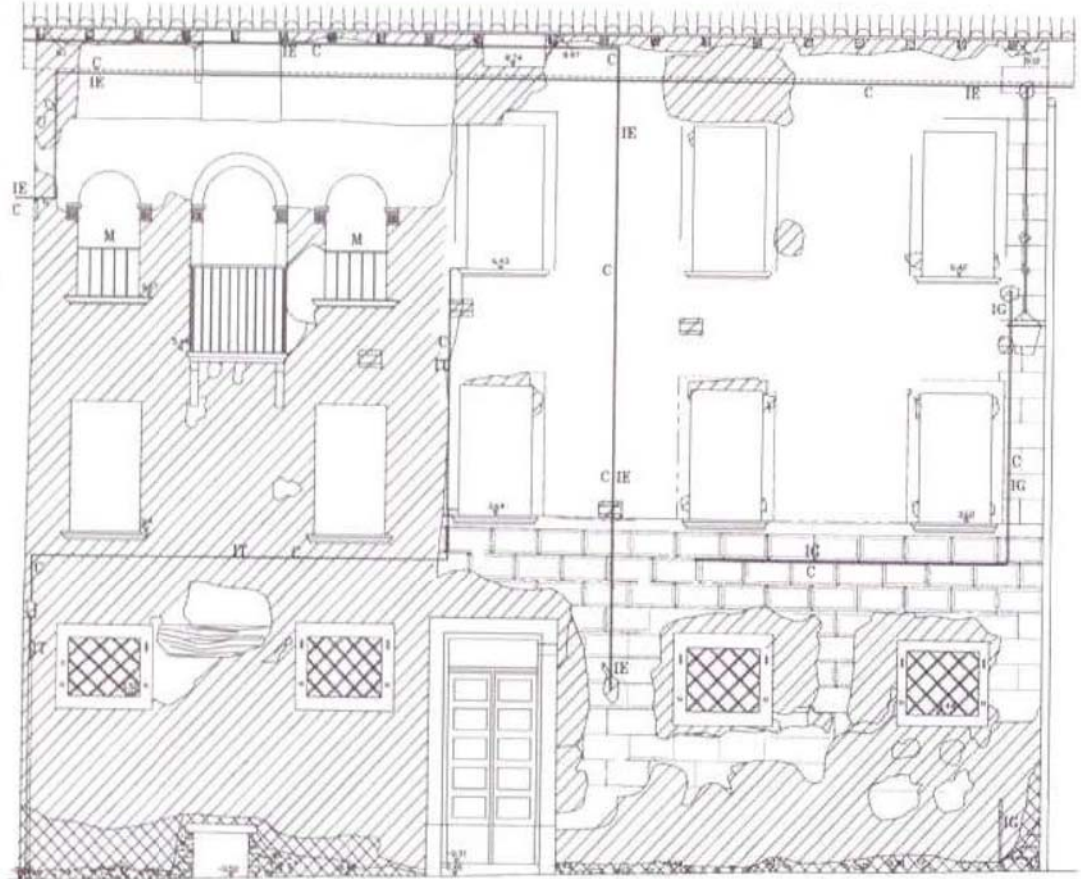
Using as a basis cartographic architectural survey on which is portrayed the perimeter of the areas subject some typical aspects of degradation, such as surface deposit , cracking, cracking, fracturing, scaling, alveolization, black crusts, pitting, corrosion, spotting, efflorescence, detachment, etc.

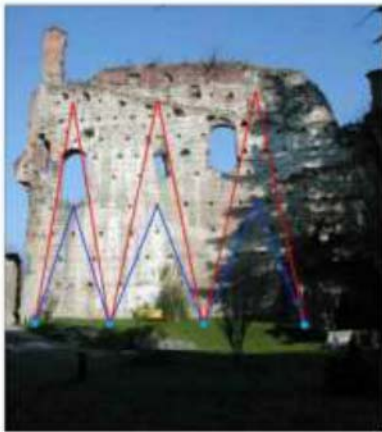
FOTO 1 - Schema di posizionamento trattori di consolidamento del muro del Castello, all'interno delle buche portali esistenti

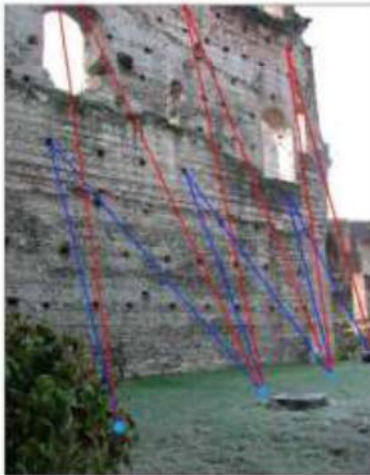
FOTO 2 - Schema di posizionamento trattori di consolidamento del muro del Castello, all'interno delle buche portali esistenti

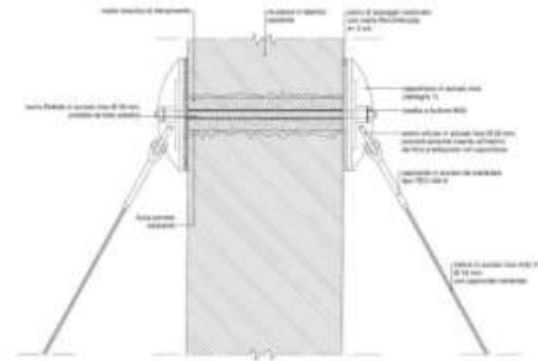
PART. 2 - Sezione verticale della muratura in corrispondenza nodo di aggancio trattori metallici-capotreno scala 1:10

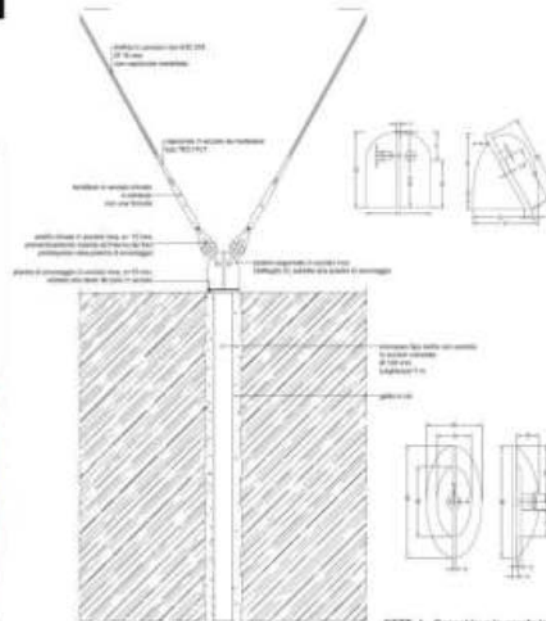
PART. 3 - Visione frontale nodo di ancoraggio trattori metallici-micropali scala 1:10

DETT. 1 - Capotreno in acciaio inox scala 1:10

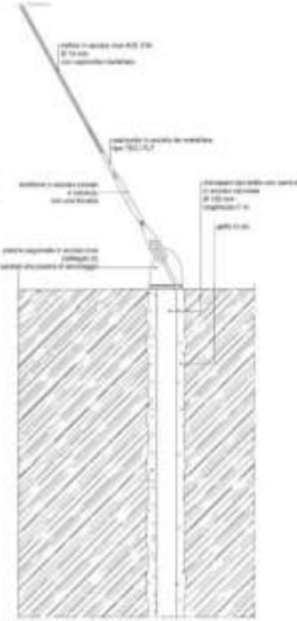
PART. 4 - Sezione verticale in corrispondenza nodo di ancoraggio trattori metallici-micropali scala 1:10
