Heritage Problems. Causes. Solutions

Sustainable Heritage

06 WALLS III: SOLUTIONS

Project "SURE - Sustainable Urban Rehabilitation in Europe" implemented in frames of Erasmus+ Programme Key Action 2: Strategic Partnership Projects
Agreement n° 2016-1-PL01-KA203-026232

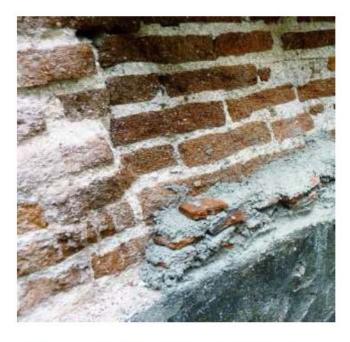
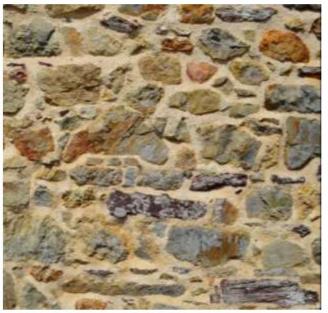
RETACADO & GROUTING

Fundamental solution to consolidate a wall. It must be cleaned the joints to where the masonry is fixed, eliminating the mortar in bad conditions. Generally is used a similar material or similar characteristics of hardness, porosity, elasticity, etc. But it may be aesthetically very different looking for its formal differentiation. Sometimes it is delimited when it is carried out on a surface to be considered.

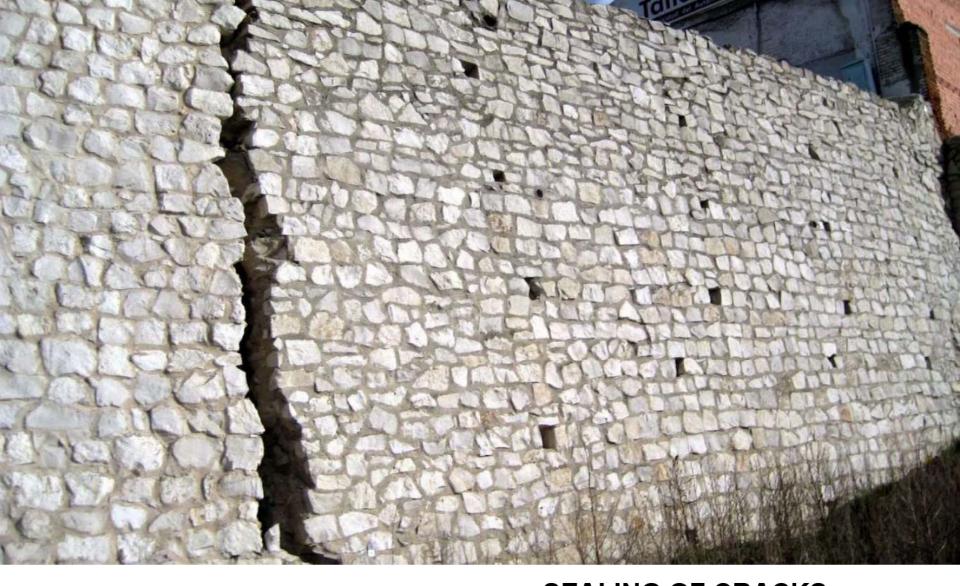
SEALING OF CRACKS
Mortar
Epoxy resins

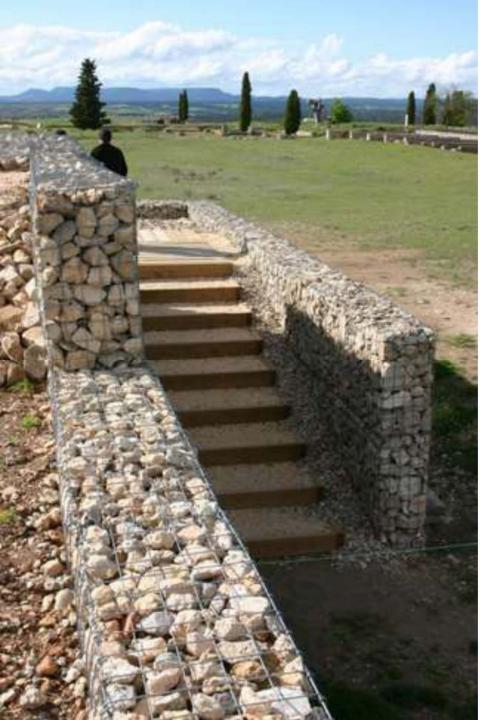
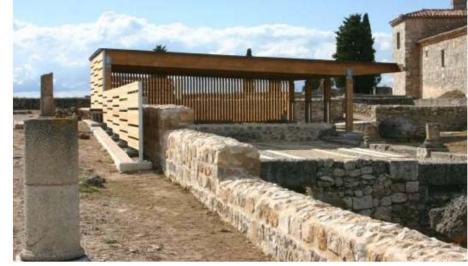
EDGES CONSOLIDATION

Slope mortar Sacrificial layer Stone gabions

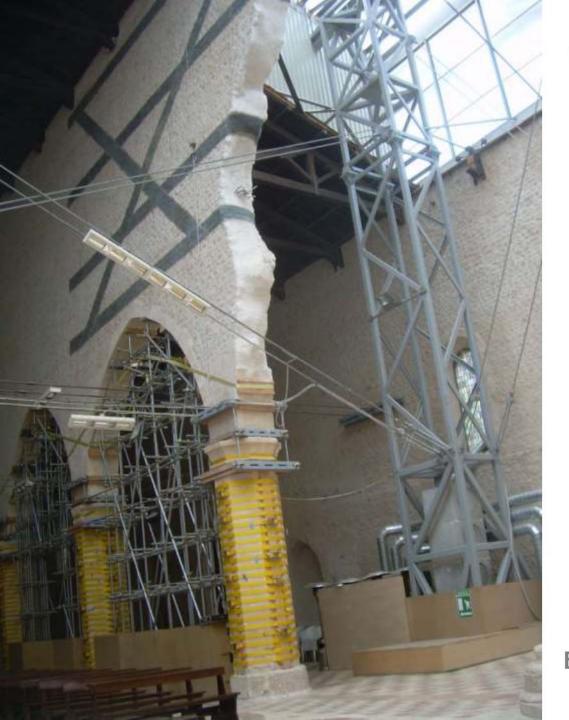
FIBERS EXTERNAL REINFORCEMENTS

Use of carbon fiber as laminates in reinforcements for pillars and walls

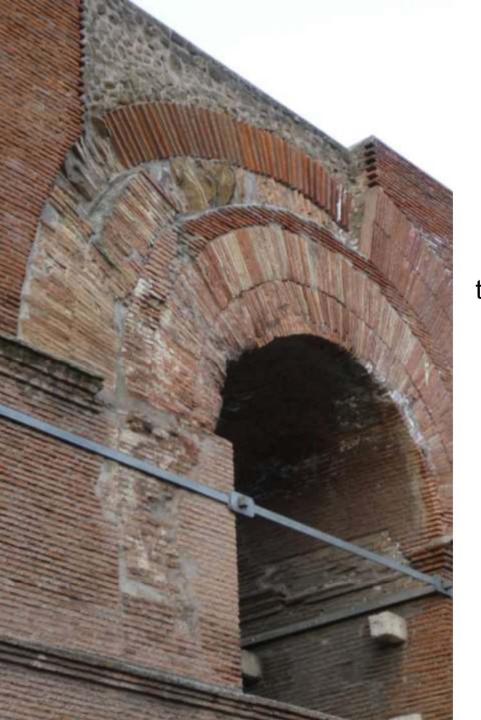
INJECTIONS **REINFORCED**

- Constructive system changes
- Static / Hyperstatic
- Expulsion of the bars
- Homogeneous systems
- Compatibility

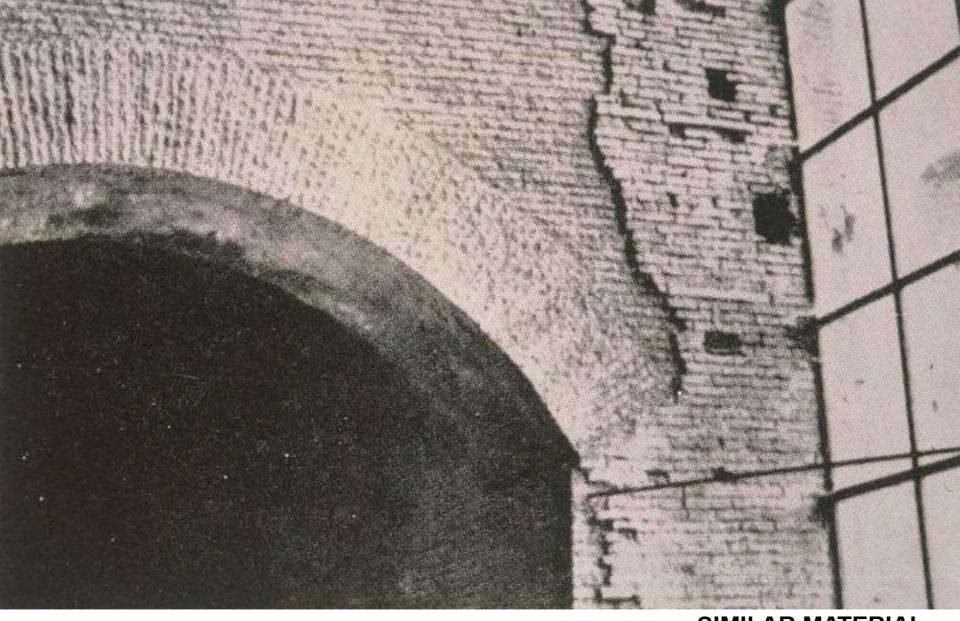
SIMILAR MATERIAL REINTEGRATION

Technique that allows aesthetically integrate a work completing its losses. To reduce the visual impact of damage and lacunae on a work, thus increasing its artistic and iconographic legibility. Should be clearly distinguishable when viewed at close proximity. Materials to be employed should be compatible with the original and reversible. A distinction is to be drawn between lacunae that can be reconstructed and those that cannot, as they require different methods of reintegration.

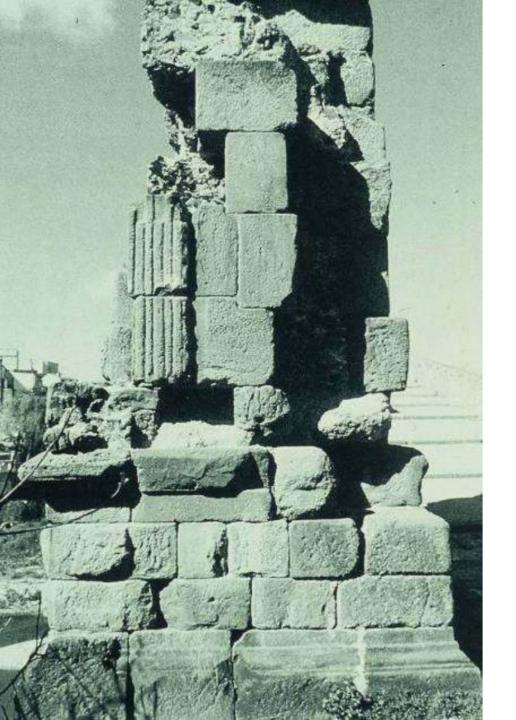
06 WALLS III SOLUTIONS ANASTYLOSIS

Placement of pieces and/or elements demolished in the place that originally occupied.

Can help with metallic elements, buttress, etc. or from another neutral material to place them.
