Heritage Problems. Causes. Solutions

1. INTRODUCTION
2. FOUNDATIONS: DAMAGES
3. FOUNDATIONS: REPAIR SOLUTIONS
4. WALLS: CONSTRUCTIVE SYSTEM
5. WALLS II: PROBLEMS AND CAUSES
6. WALLS III: SOLUTIONS
7. VAULTS: CONSTRUCTIVE SYSTEM
8. VAULTS II: PROBLEMS AND CAUSES
9. VAULTS III: SOLUTIONS
10. FLOORS
- 11. WOOD**
12. ROOFS: CONSTRUCTIVE SYSTEM, PROBLEMS
AND CAUSES
13. ROOFS II: SOLUTIONS
14. OTHER TRADITIONAL STRUCTURES
15. SURFACE FINISHES, INTERIOR WOODWORK

11 WOOD

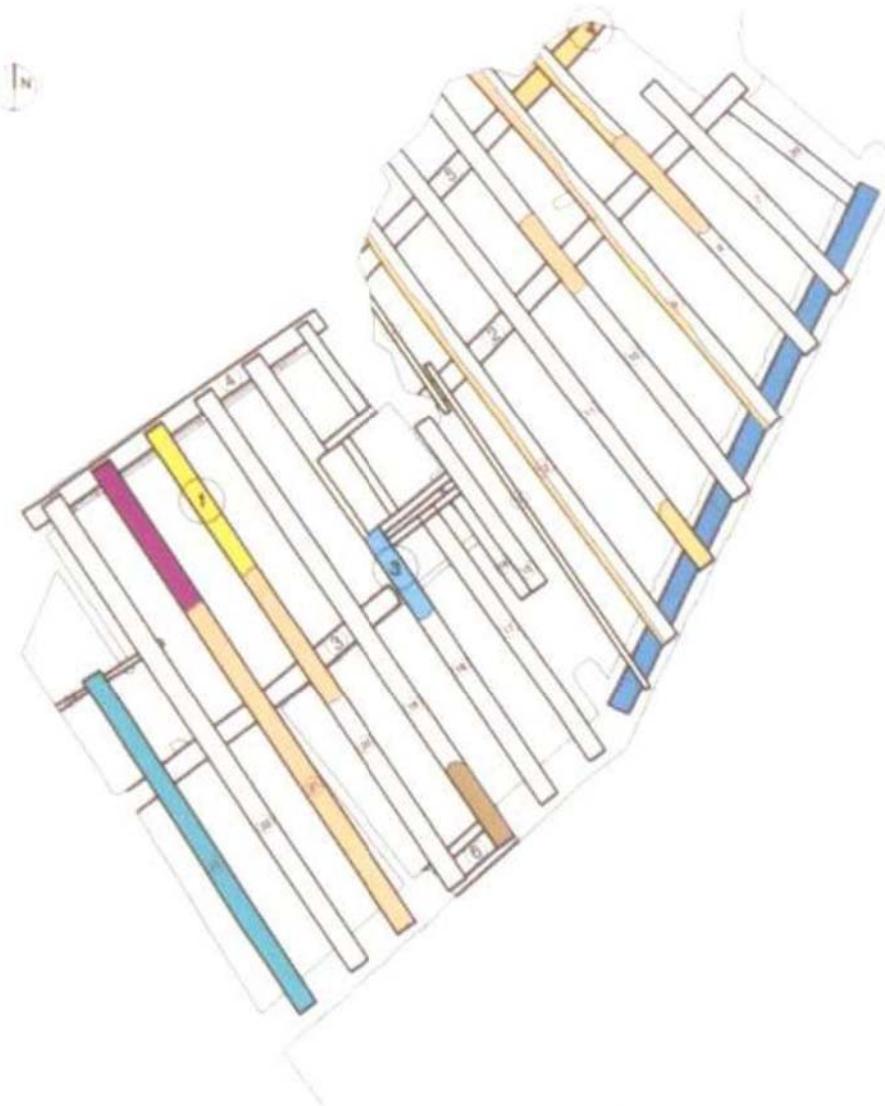
| Insectos vórticos (cucarachas) | Madera cuarterada | Madera cuarterada y pudrición |
| Insectos vórticos (ardillas) | Pudrición | Madera cuarterada y xilófagos |
| Insectos vórticos (hermitas) | Marchas de humedad | Hongos |
| Madreja acorchaada y manchas de humedad | Insectos vórticos y pudrición | Nido de aves |
| Madera acorchaada | Madera acorchaada y pudrición | Rosuras |

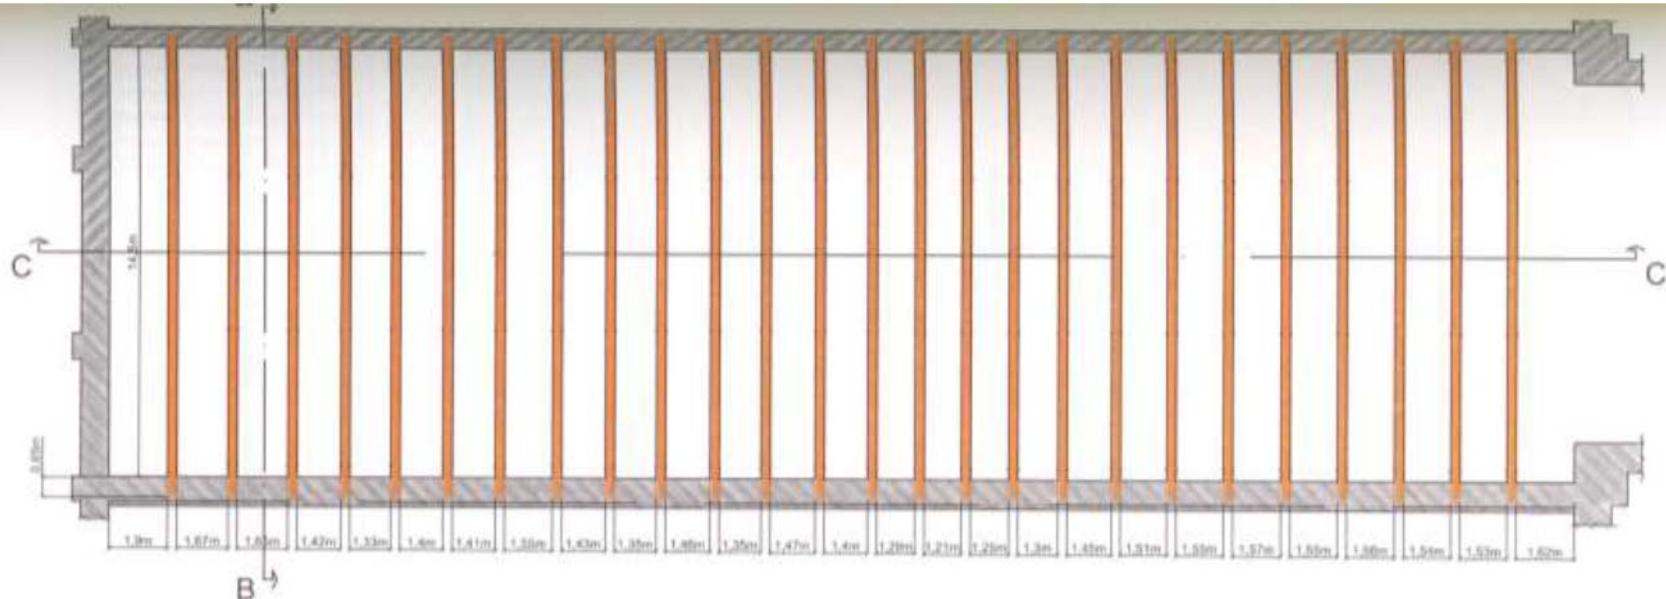
rilievo della copertura - sezioni navata centrale

Sezione C-C navata centrale

Sezione B-B navata centrale

Schema pianta Basilica

Schema capriata scala 1:50

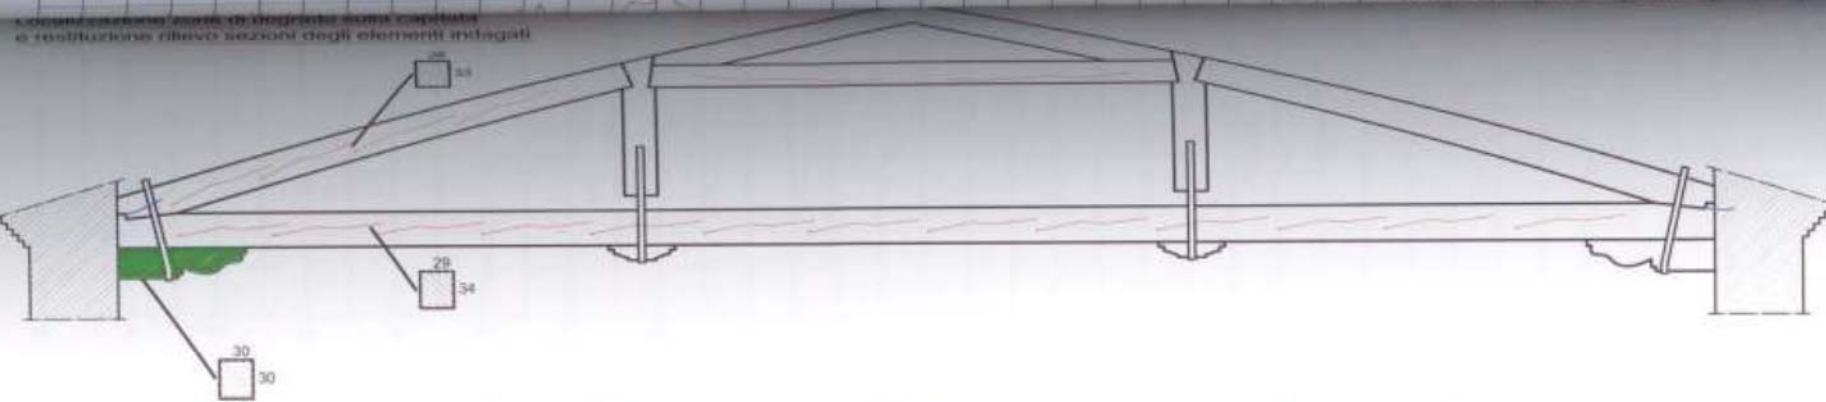
A: attacco biotico di entità grave

B: attacco biotico di entità media

C: attacco biotico di entità contenuta

D: rottura del dente di taglio sulla catena con scorrimento relativo degli elementi:

E: lesione in corrispondenza del dente di taglio localizzata su catena e/o puntone:

F: presenza di fessurazioni da ritiro

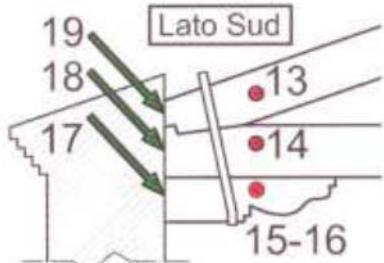
localizzazione e codifica prove resistografiche sulla capriata

perforazione a 45°
● perforazione a 90°

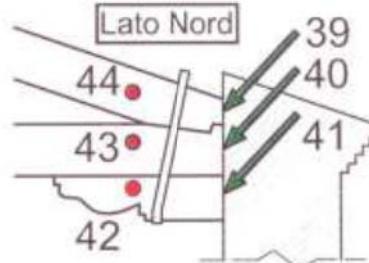
localizzazione della capriata indagata

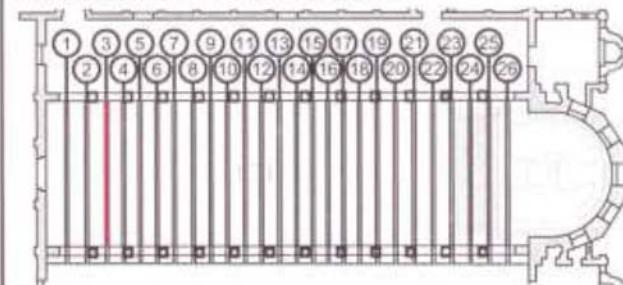
riconoscimento tipologico delle essenze legnose

- parti in legno di Larice (*Larix decidua*)
- parti in legno di Pino (*Pinus sylvestris*)

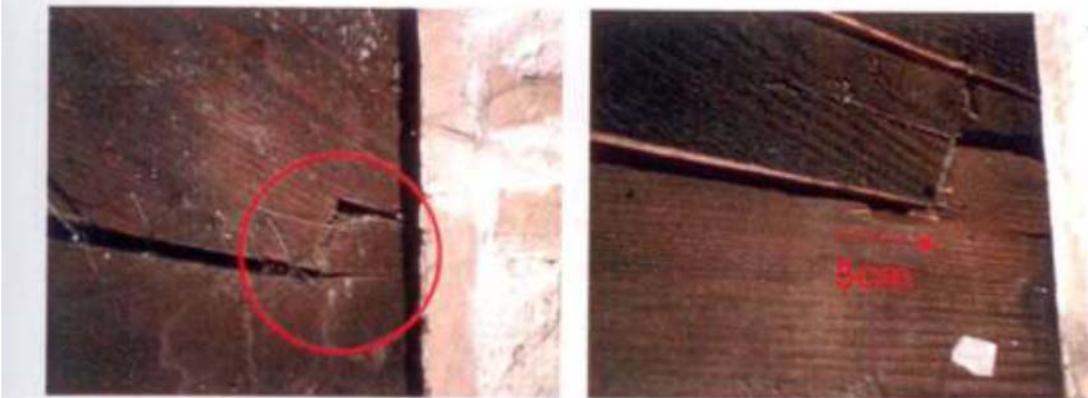
damage of the mortising and breaking of the same with relative sliding of the elements

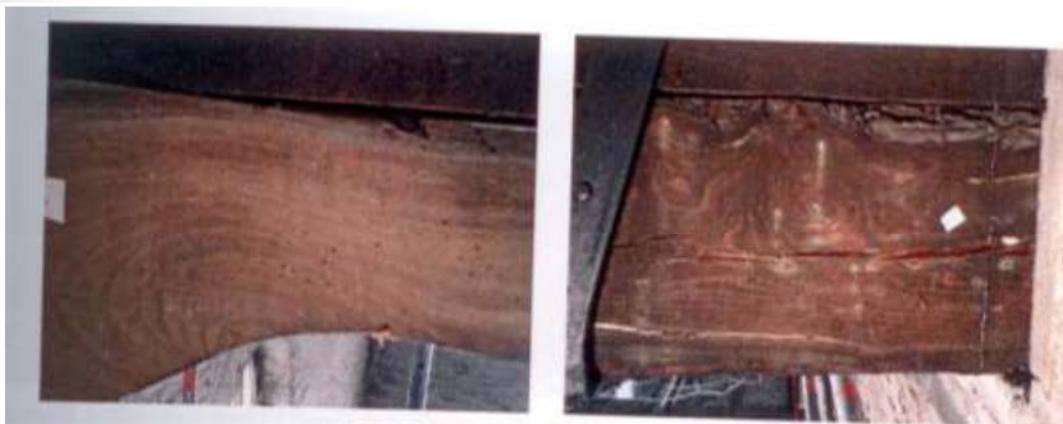
attack of anobid and cerambycid xylophages

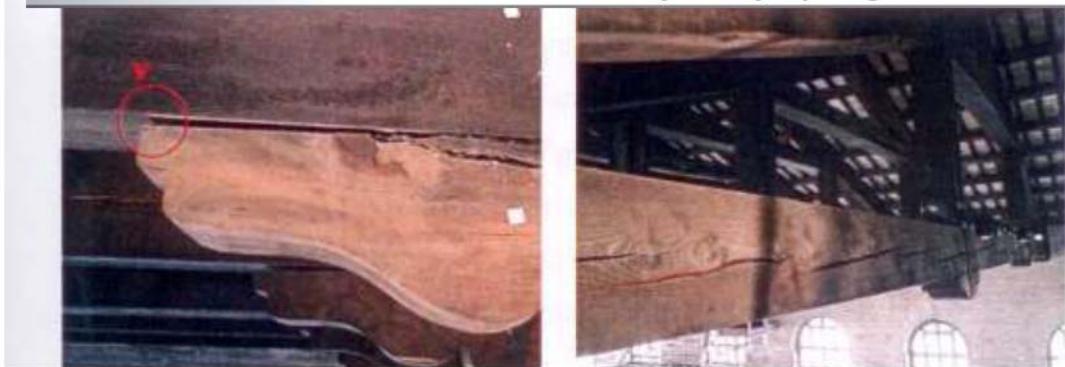
vertical deviation between bracket and chain and longitudinal cracks due to withdrawal on the chain

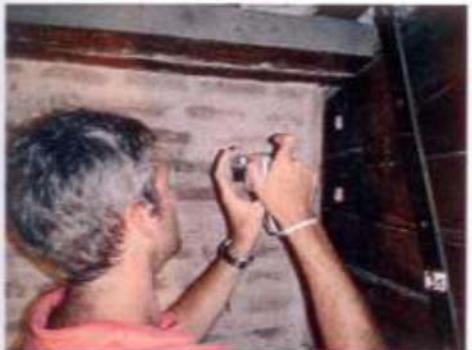
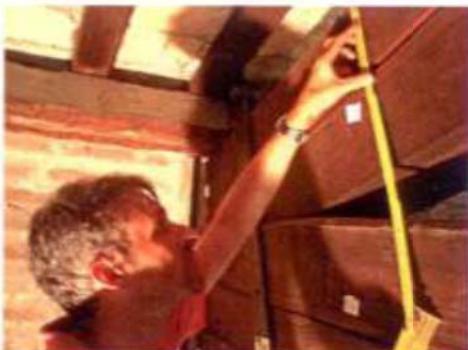
visual, photographic and geometric survey

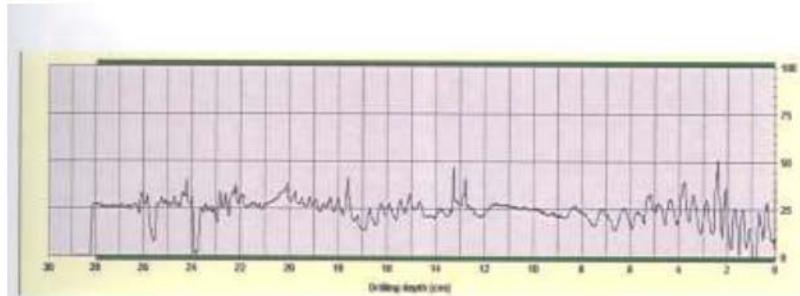
depth-resistance diagram of a healthy bracket

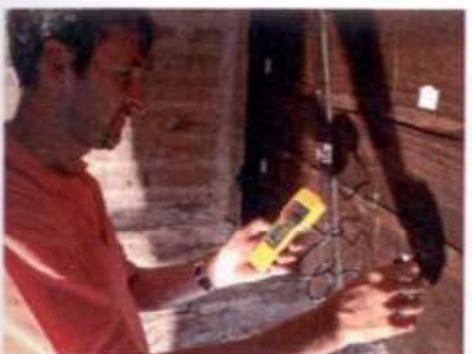
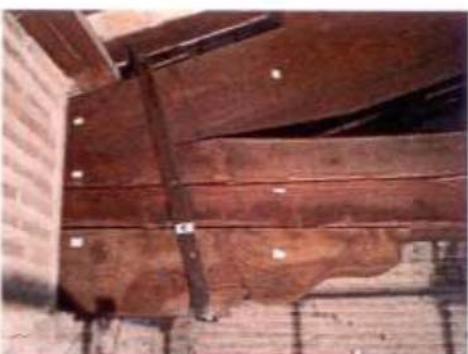
moisture survey and example of the coding assigned to the truss with indication of the execution points of the perforations

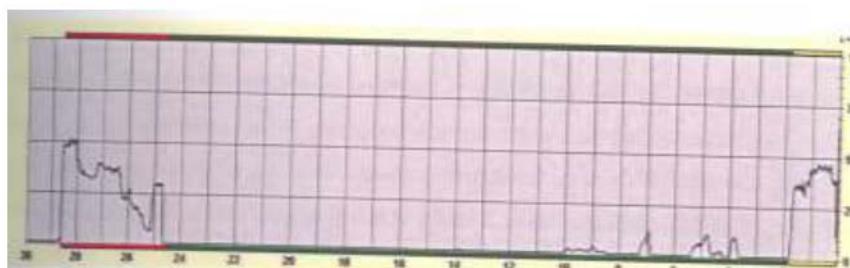
depth-resistance diagram of a deteriorated bracket

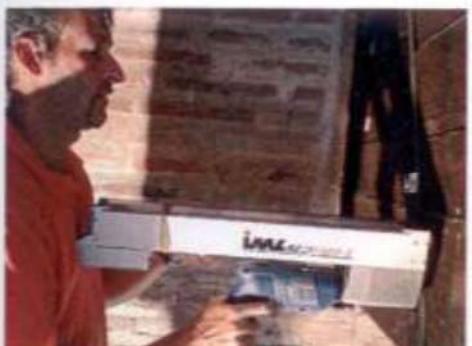
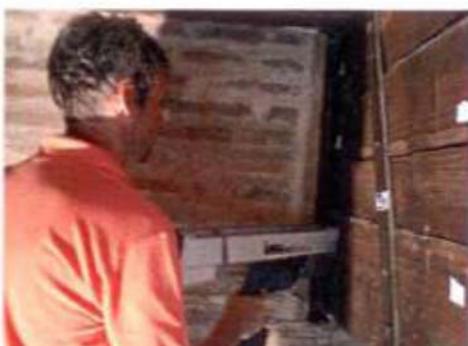
perforations with resistograph, in the section and in correspondence of the support

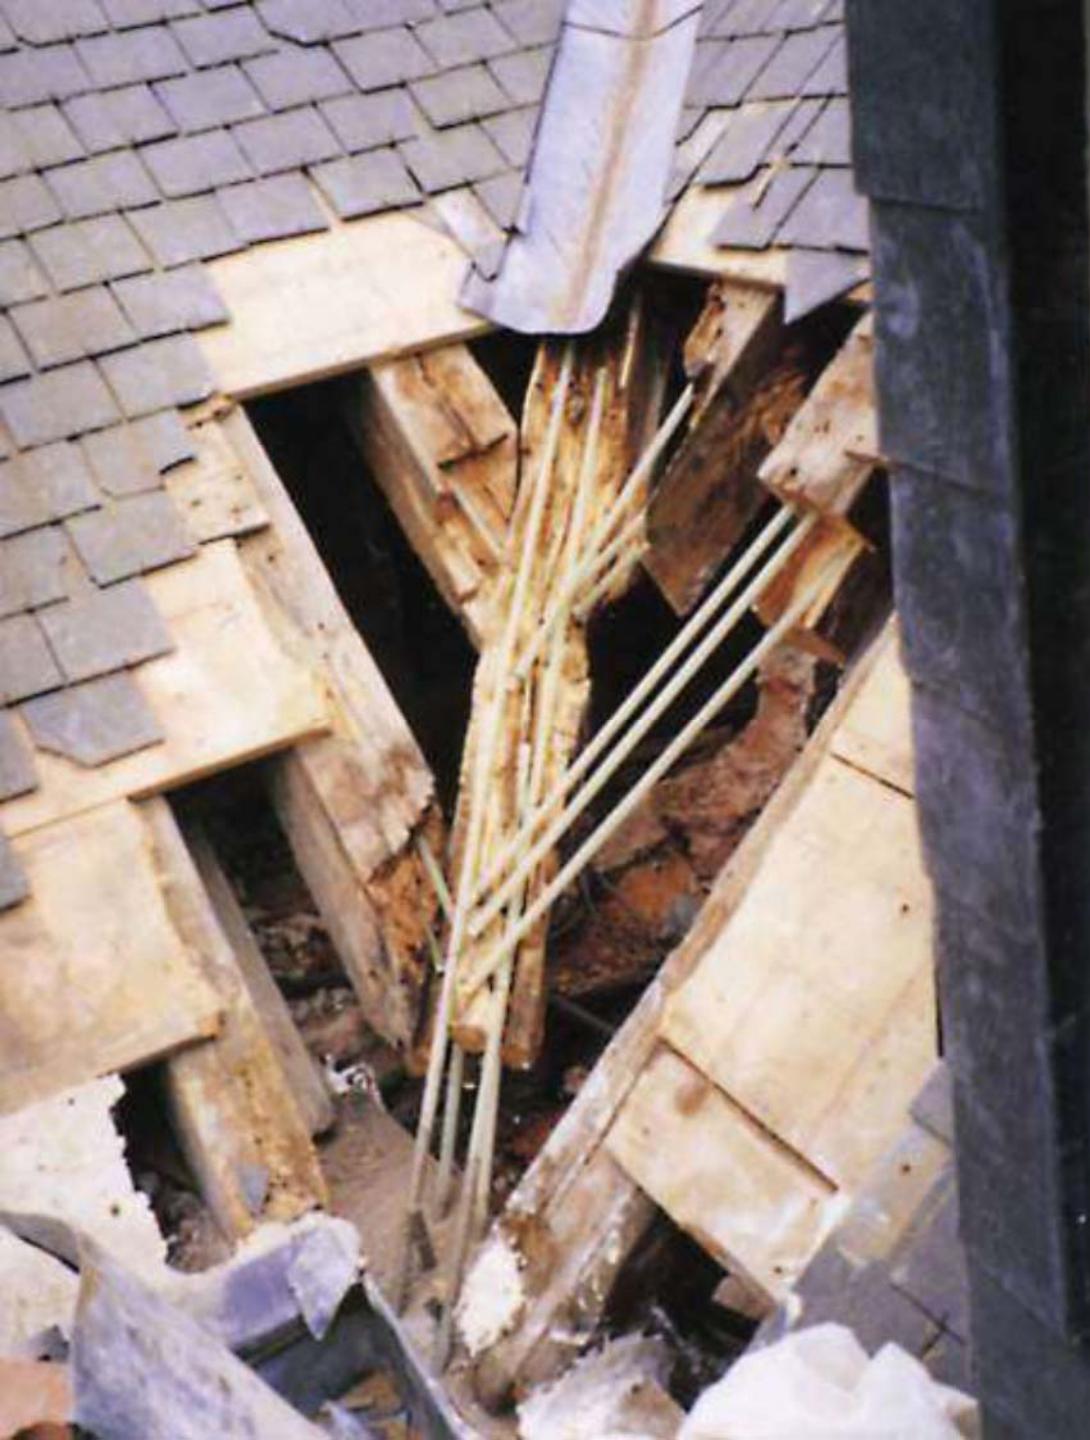
A technique for consolidating structural wood elements that permits the recuperation not only of their mechanical capacity but also their original appearance. This technique doesn't require disassembling elements because the treatment is done on-site,

Steps of the Beta System:

1. Elimination of damaged wood from the support of a scissor truss.
2. Perforation and placement of the pretensioned rods.
3. Forming and filling with epoxy resin grout.
4. Final appearance of the repaired zone.

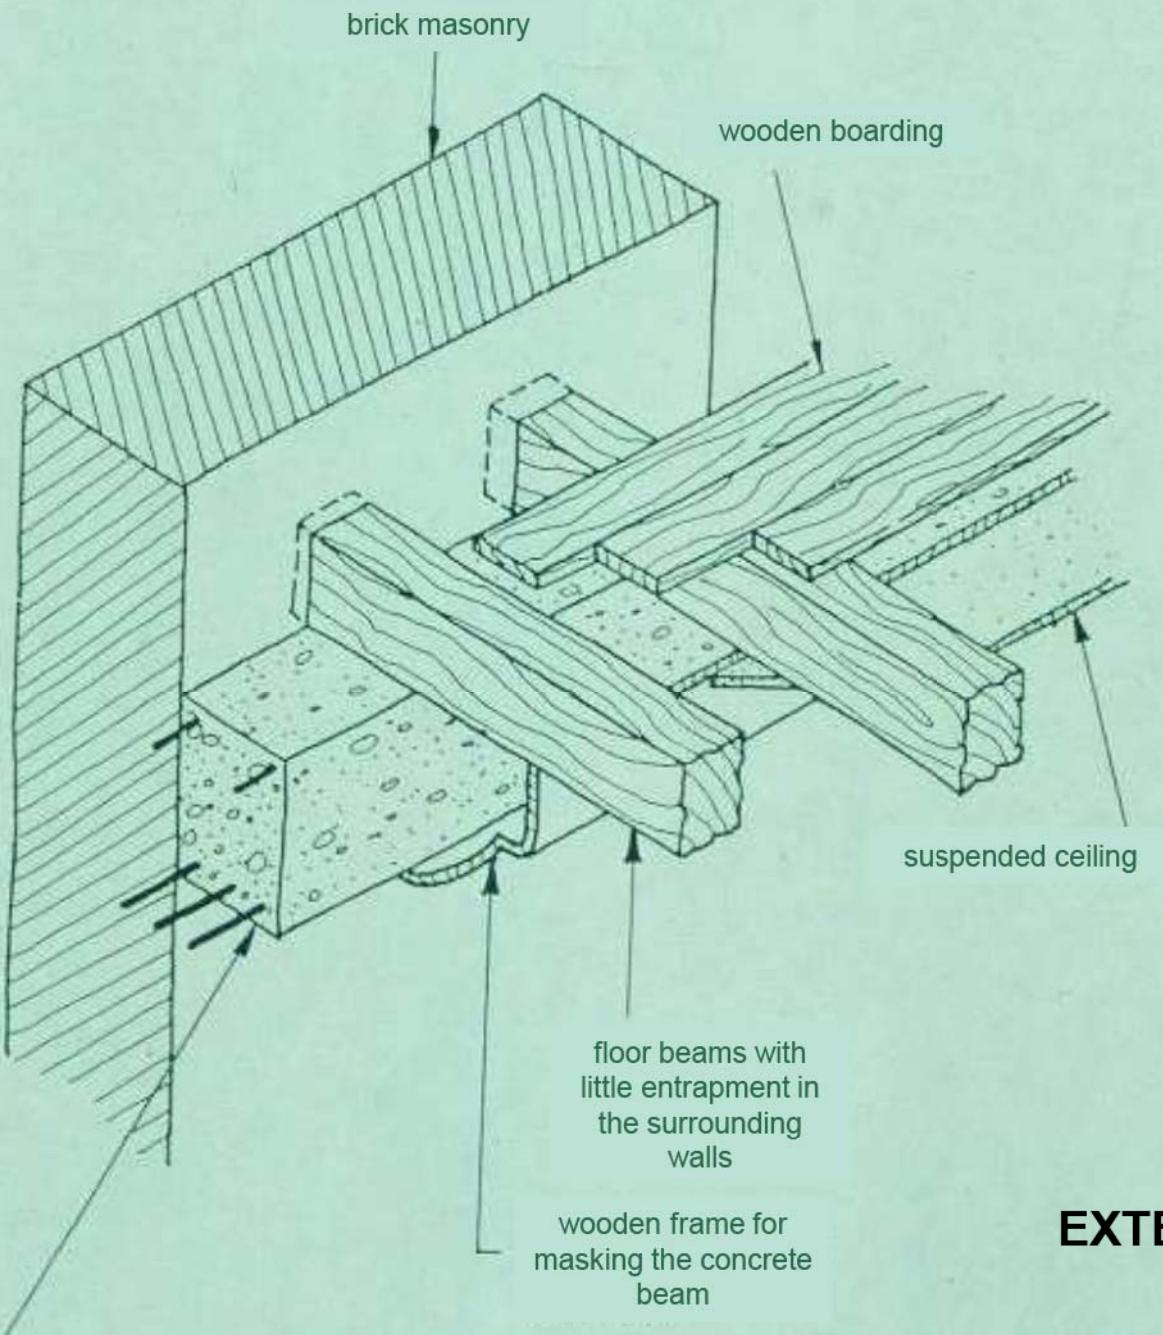
EXTERNAL REINFORCEMENTS WOODEN STRUCTURES

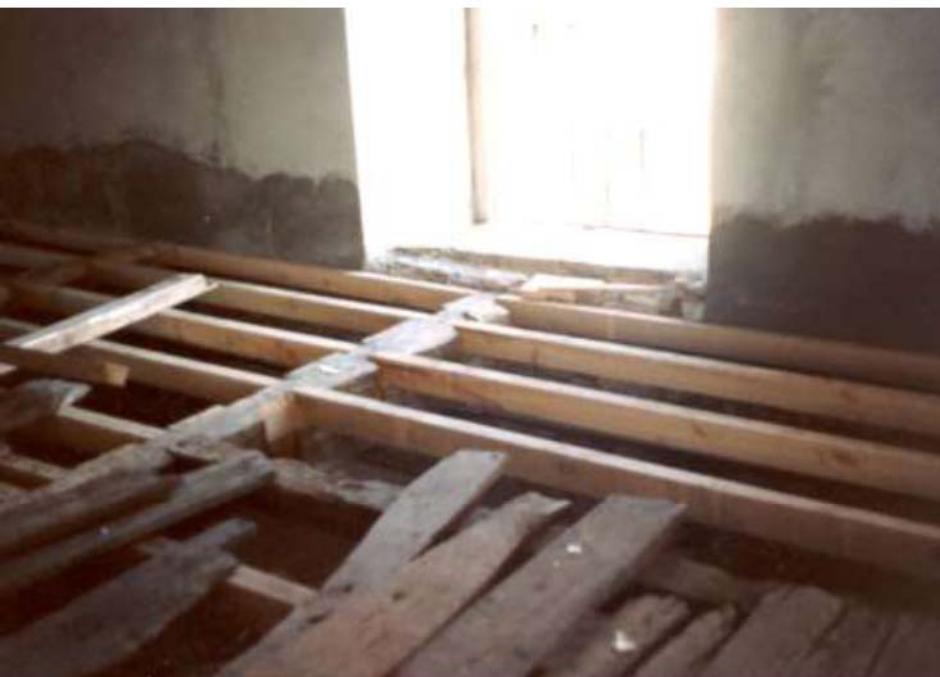
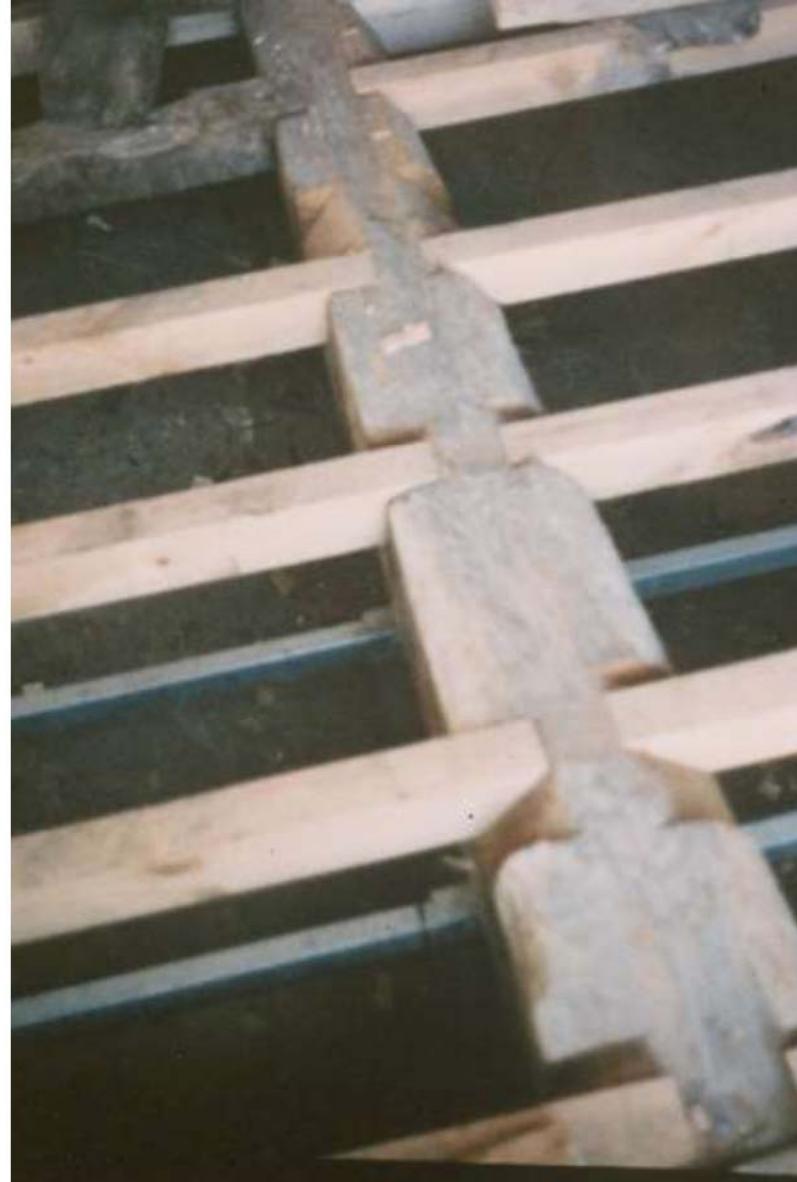
EXTERNAL REINFORCEMENTS WOODEN STRUCTURES

Reinforced concrete beam for the support of wooden floor beams

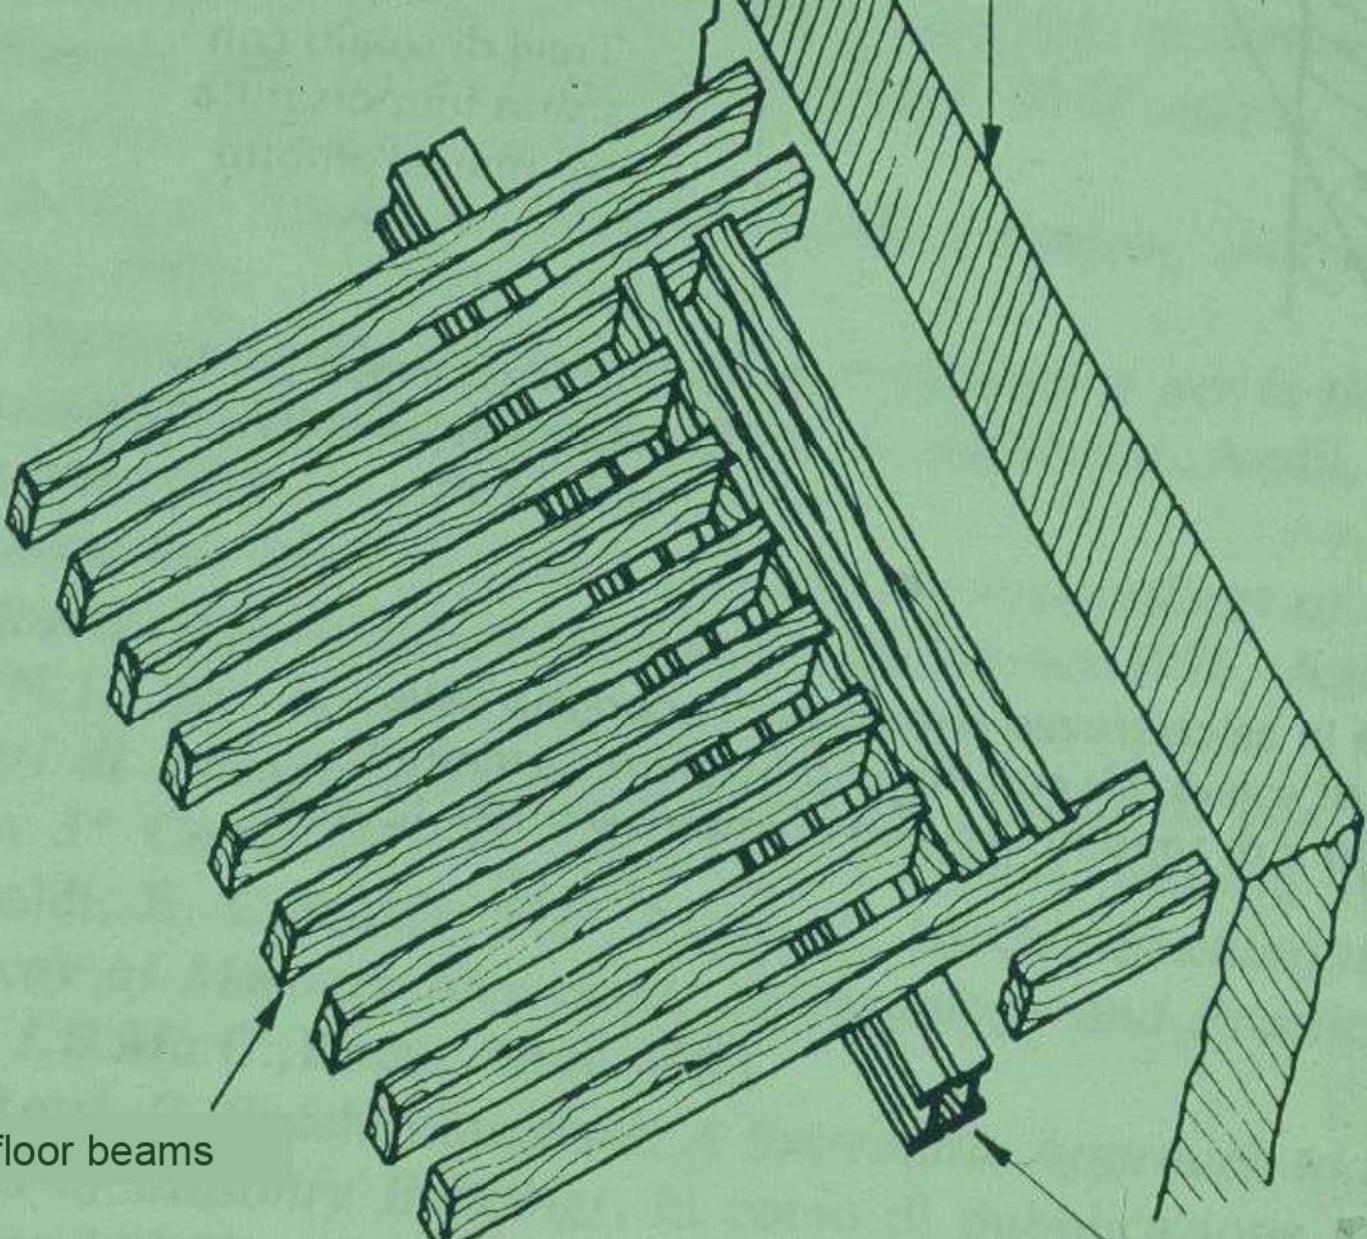
**EXTERNAL REINFORCEMENTS
WOODEN STRUCTURES**

Steel beam for the support of wooden floor beams
